Problems Associated with
Concrete Paving

Problems Associated with **Concrete Paving**

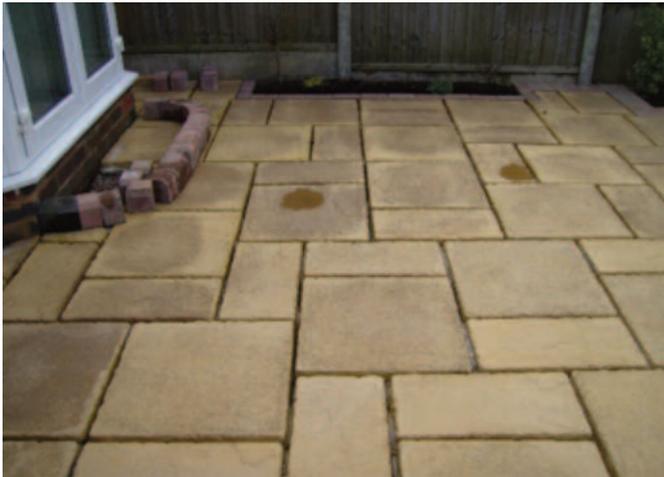
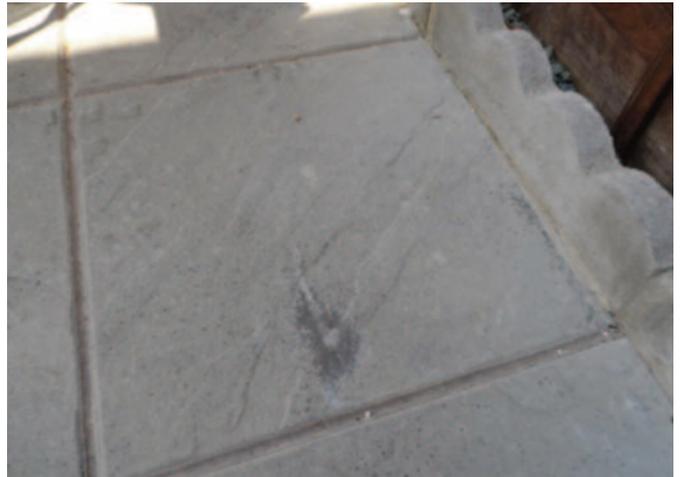
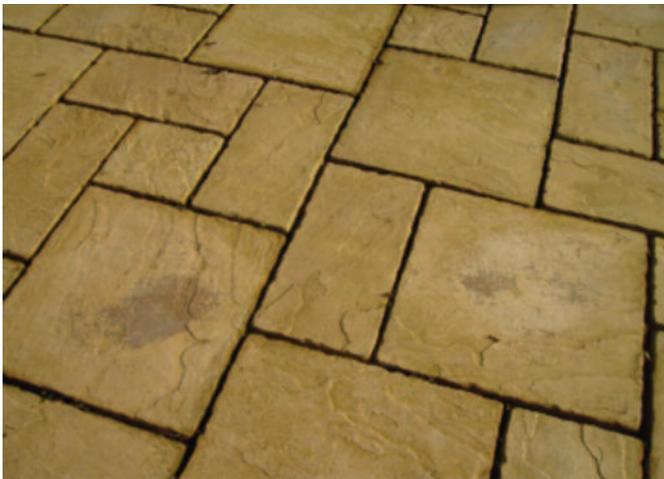
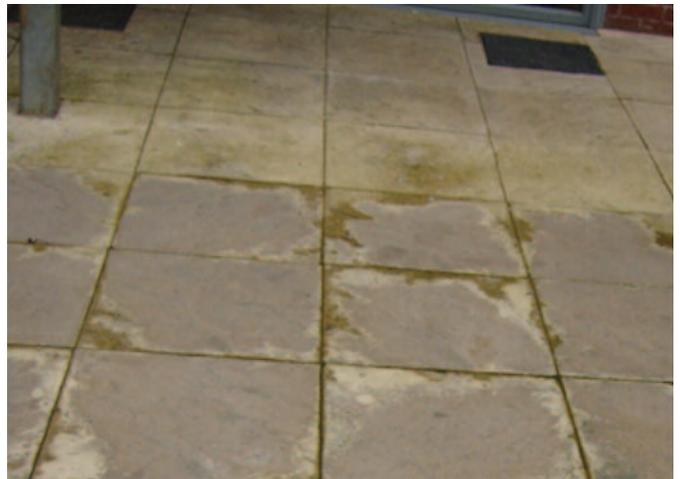
Possible Causes

Differential weathering is caused by varying moisture movement in the early curing process. The darker areas represent the moisture cured parts of the surface, and these are usually in the centre of the slab as the production technique can sometimes inhibit uniform surface drying.

Other causes of differential weathering:

Packaging – subjects the paving units to sweating within the pack.

Atmospheric conditions – the weather can affect the paving in its early curing process and when newly laid.

Paving laid on the spot bed method causes voids which can contribute to the drying out/curing process resulting in patches.

The appearance of a slab affected by differential weathering can sometimes give the impression that the concrete surface is flaking, which is not the case. The perceived flaking effect is purely the shade differential between area of the concrete surface which have been subjected to the varying moisture conditions during the products early curing process.

The effects are not detrimental to the product and not usually permanent and will become less apparent with natural weathering and with the passage of time.

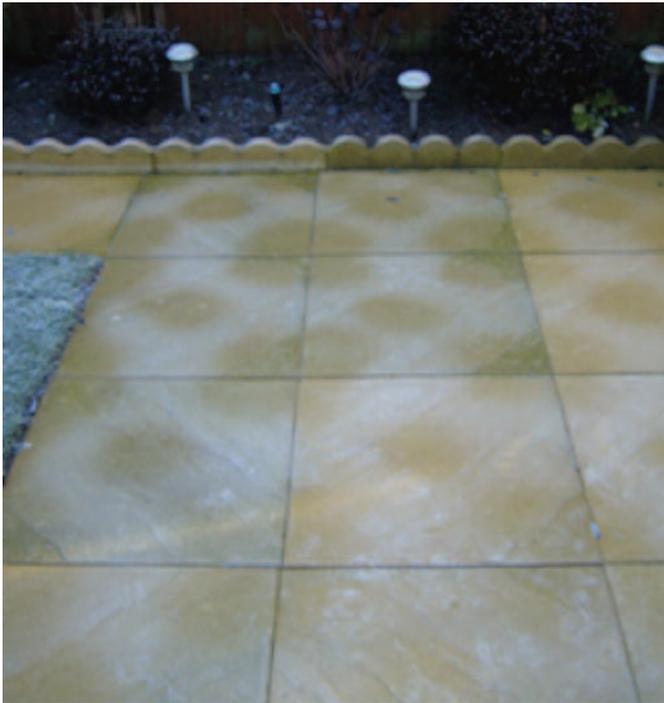
Photo also shows spot bedding.

Efflorescence is a natural phenomenon that can occur in any concrete product and does tend to disappear with the passage of time and natural weathering.

Efflorescence is known as 'lime bloom' and brought about as the result of the normal chemical reaction between cement and water. When it is wet, the deposit becomes transparent and seemingly disappears. The occurrence of efflorescence is spasmodic and unpredictable but forms more readily when concrete becomes wet and dries slowly and therefore, occurs more frequently in the winter.

Although there are efflorescence cleaners on the market, these can be a temporary solution. Be assured that efflorescence will generally disappear with natural weathering and time.

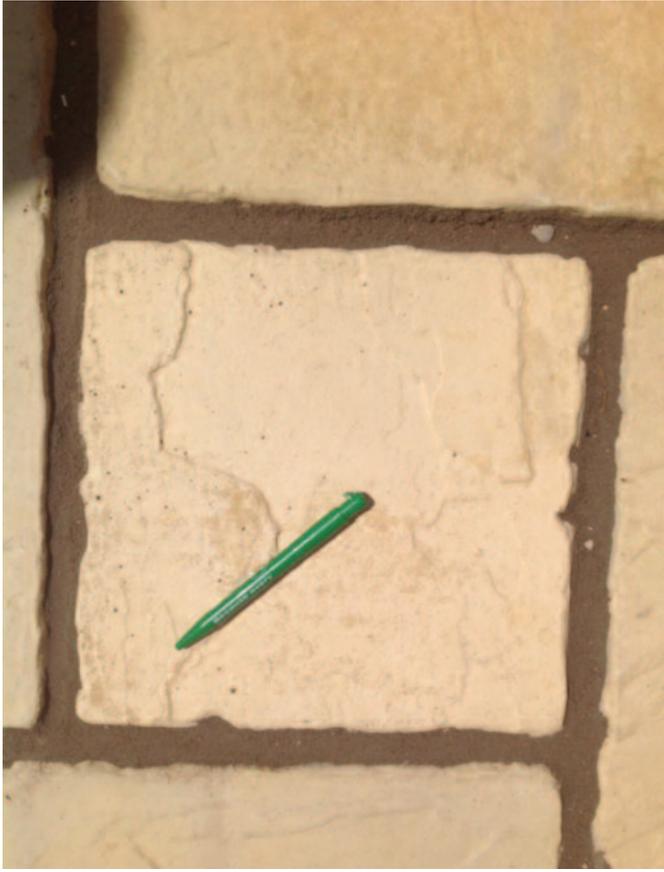
Mainly occur during the manufacture of wet-cast paving slabs.

Generally air holes/pin holes in concrete are small and not detrimental to the future performance of the paving.

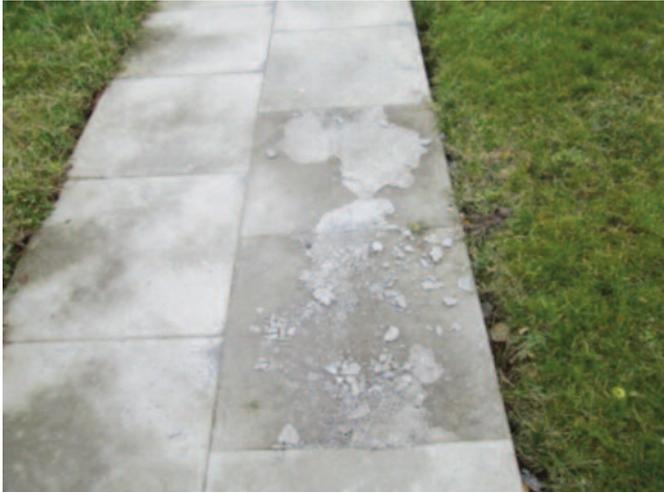
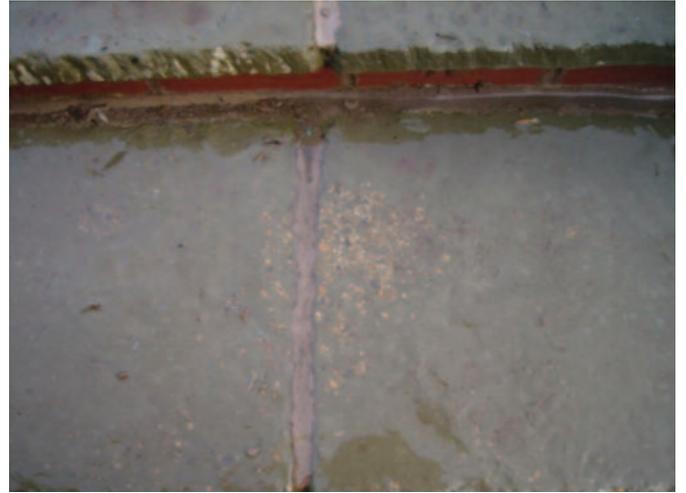
The break-up of paving surfaces can be due to the use of rock salt, which is generally applied on pathways or access routes. Rock salt should not be used on concrete paving and we state this in our brochure and on our website, most suppliers of rock salt will also state it's unsuitability for the use on concrete and asphalt roads and pathways.

The detrimental effects of rock salt use can be seen clearly over recent heavy winters with the appearance of the unprecedented number of pot-holes on roads across the country.

Once applied there are no resolutions, although without the further use of salt paving should not deteriorate any more, and in future winters the use of grit is recommended.

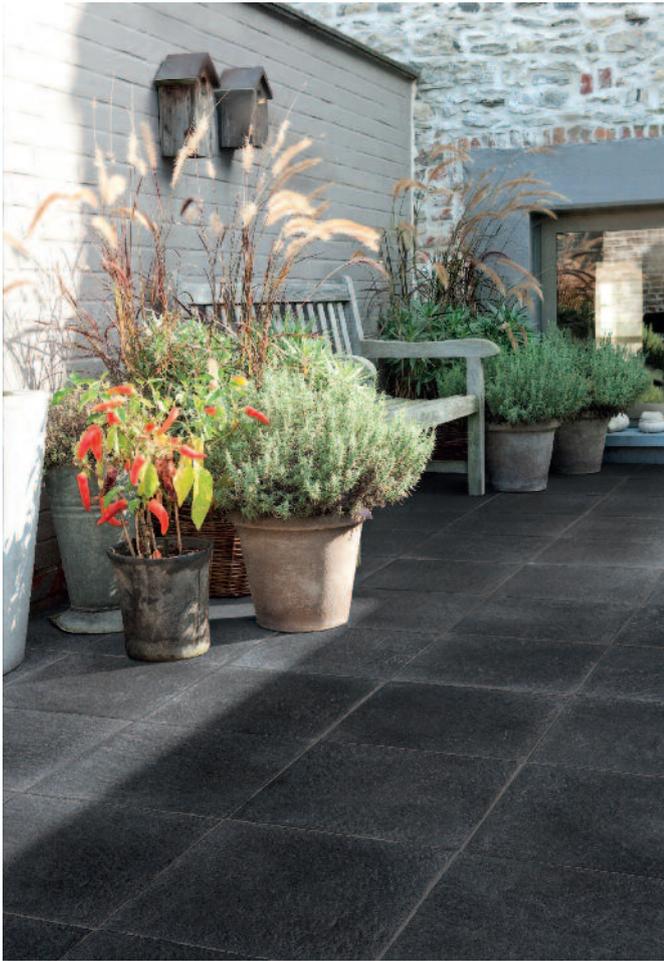
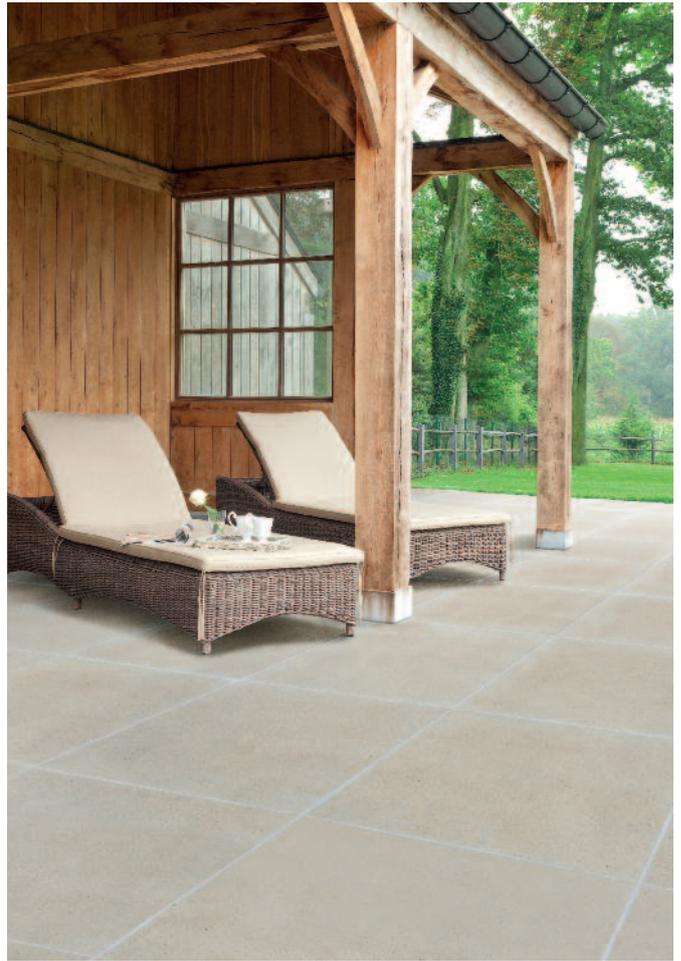
Manhattan and Kera Linea have a 10 year guarantee, however, they are not self-cleaning and still need to be maintained and looked after.

Prior to laying the paving should be handled with care and stacked face to face.

Cleaning products recommended:

Scratch repair kits are available.
